Name of Dam: Coles Run *Dam*

Inventory Number: VA 01519

**PHASE I INSPECTION REPORT**  
**NATIONAL DAM SAFETY PROGRAM**

Name of Dam: Coles Run  
State: Virginia  
County: Augusta  
Stream: Coles Run  
Date of Inspection: 13 July 1978

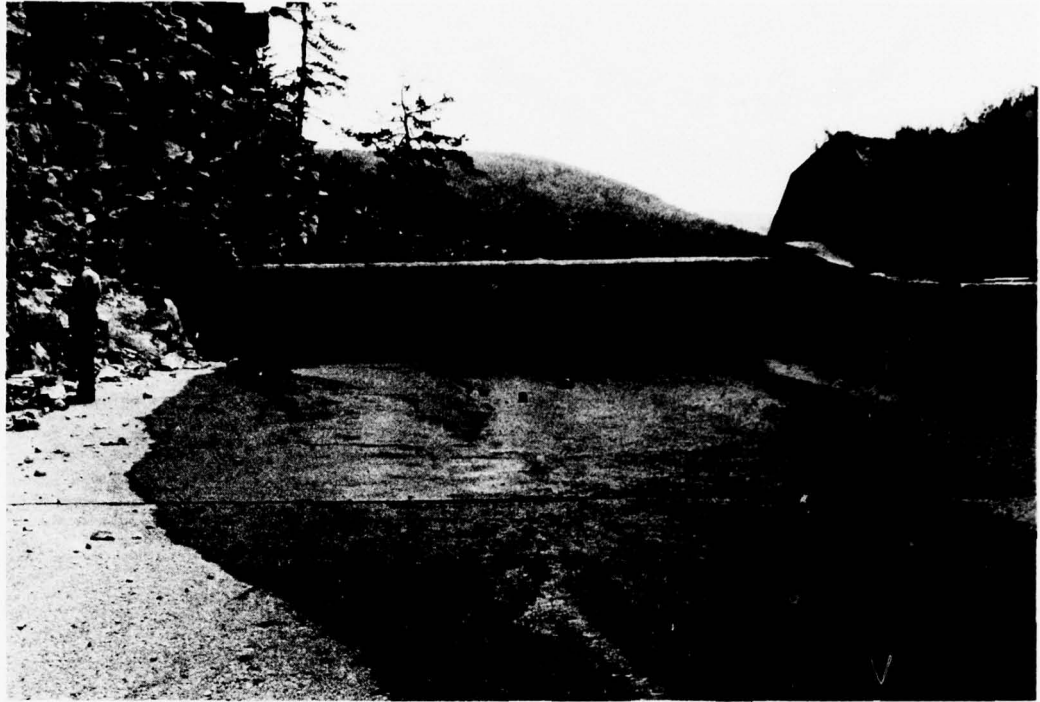
- 3.1.3 Appurtenant Structures: Some water was leaking through the flashboards at the areas of contact between the spillway concrete and the wood of the flashboard. Cracks have appeared at the jointure of the old and new concrete of the widened spillway.

- 3.2.2 Appurtenant Structures: The flashboards are leaking water but they appear to be in good physical condition. The cracks in the spillway bottom slab are minor.
- 3.2.3 Reservoir Area: The reservoir area is in good condition.
- 3.2.4 Downstream Channel: The downstream channel is in good condition.

**PHOTO 1. Weir in Spillway With Leakage Principally on Right Side Near Dam**

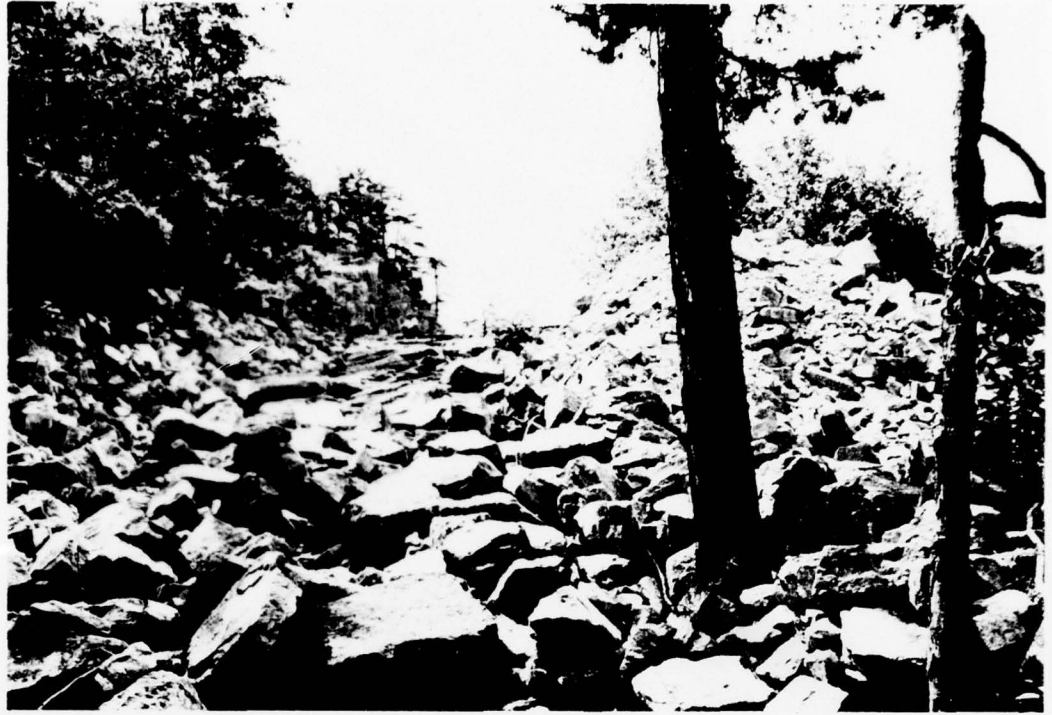
PHOTO 3. Rocks in Channel Downstream From Open Spillway

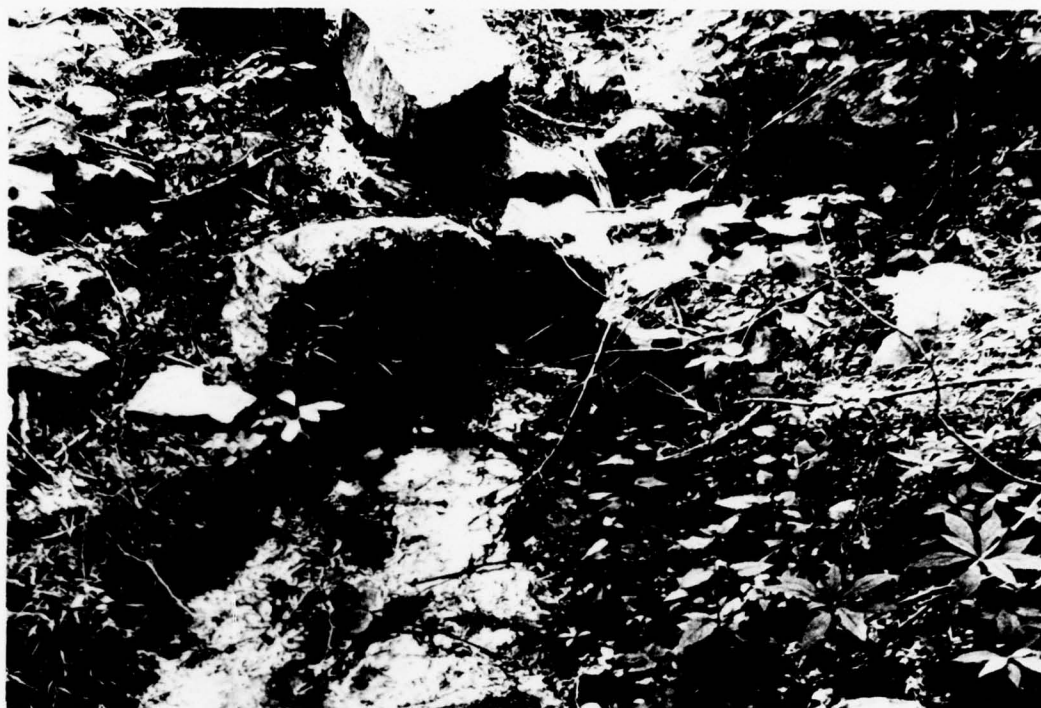
- 3.1.2 Dam: The embankment was in good condition with minor clear seepage noted at two places. Non-measurable seepage was observed from sandstone and rockfill near the 72 inch conduit outlet. Clear seepage (red in color due to iron staining) amounting to 0.25 g.p.m. was observed near the downstream toe. In addition, an eight inch drainpipe from the rock toe on the right side of the dam was flowing at 10 g.p.m. There is a heavy growth of small trees and brush on the downstream face and a few bushes on the upstream face.

**PHOTO 5. Seepage of Red Water at 0.25 G. P. M. From Downstream  
Rock Toe Drain in Old Channel**

- 3.2.1 Dam: The embankment is in good physical condition except for the heavy vegetation, which should be removed. In addition, the small trees and brush beyond the toe of the dam should be removed, especially in the downstream channel of the emergency outlet. The seepage areas should be monitored especially during periods of higher reservoir levels to detect any increase in flow.
